LOWER HOUSATONIC RIVER BASIN  
SHELTON, CONNECTICUT

TRAP FALLS RESERVOIR DAM  
CT 00091

PHASE I INSPECTION REPORT  
NATIONAL DAM INSPECTION PROGRAM

AUGUST 1978

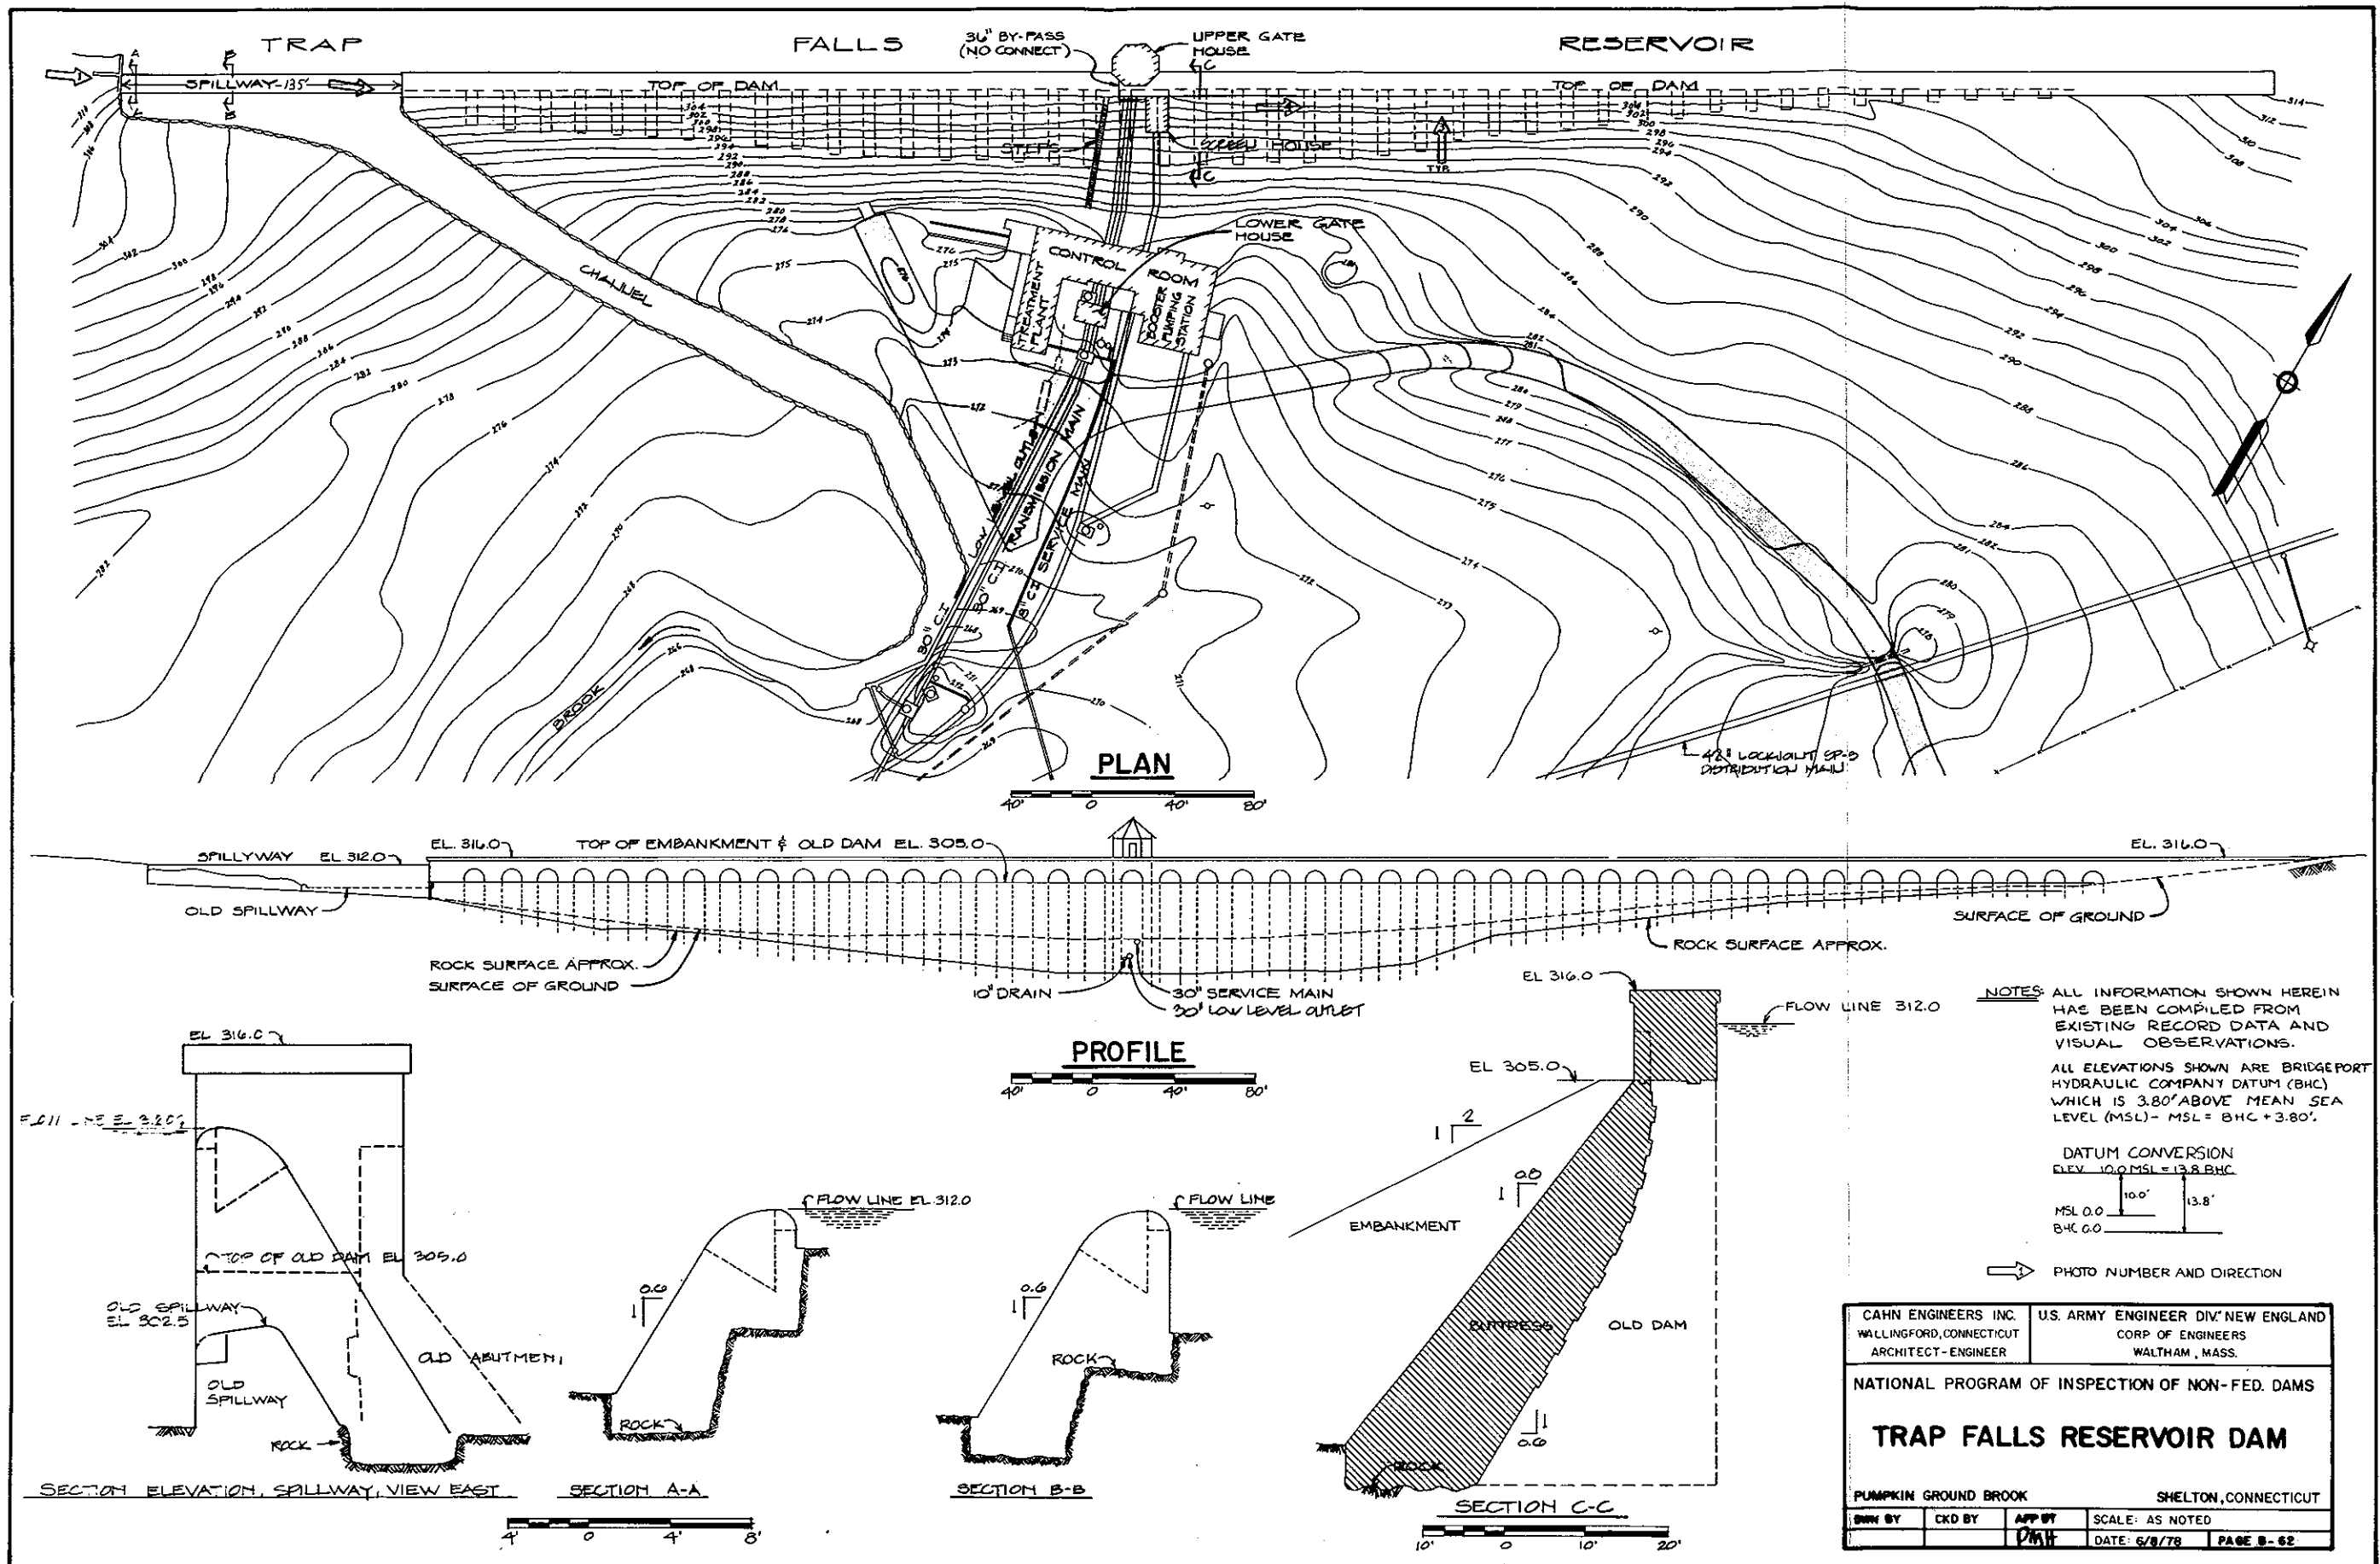
### Downstream Face of Dam

The earthen embankment buttressing the dam appears to be in good condition. No seepage was observed along it. The concrete section exposed along the top of the dam is in poor condition but appears to be structurally sound. Most of the vertical joints are badly deteriorated at the face of the dam. Reinforcing bars are even exposed at some joints. Corrective action should be taken soon so that serious structural damage does not occur.
